CONCRETE CLOTH™ DITCH LINING CASE STUDIES

29.09.10 Case Study : Golborne, Warrington

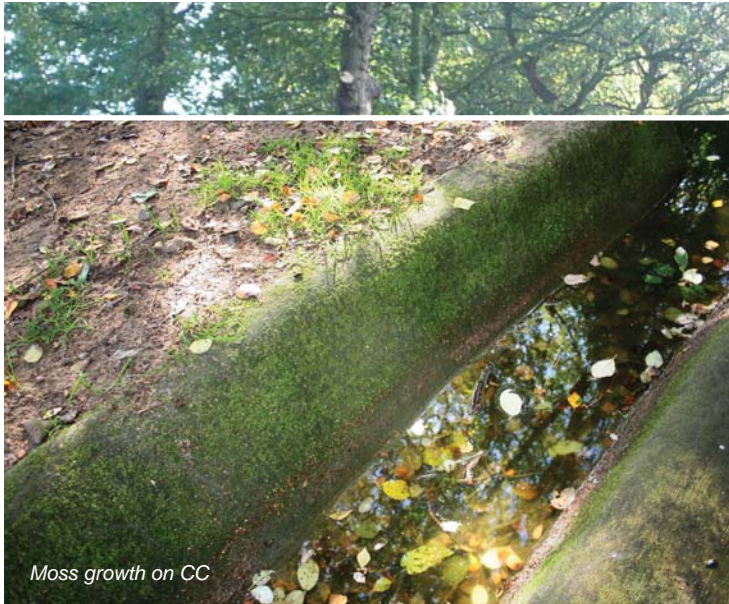
Moss growth on CC

A key benefit of using CC, is it's ability to conform to the natural contours of a ditch, providing an aesthetic in keeping with the surrounding environment. CC will naturally 'green' over time as the textured top surface allows moss growth, whilst the fibre-reinforced concrete layer will prevent root-growing vegetation, which would otherwise restrict water flow and increase maintenance costs.

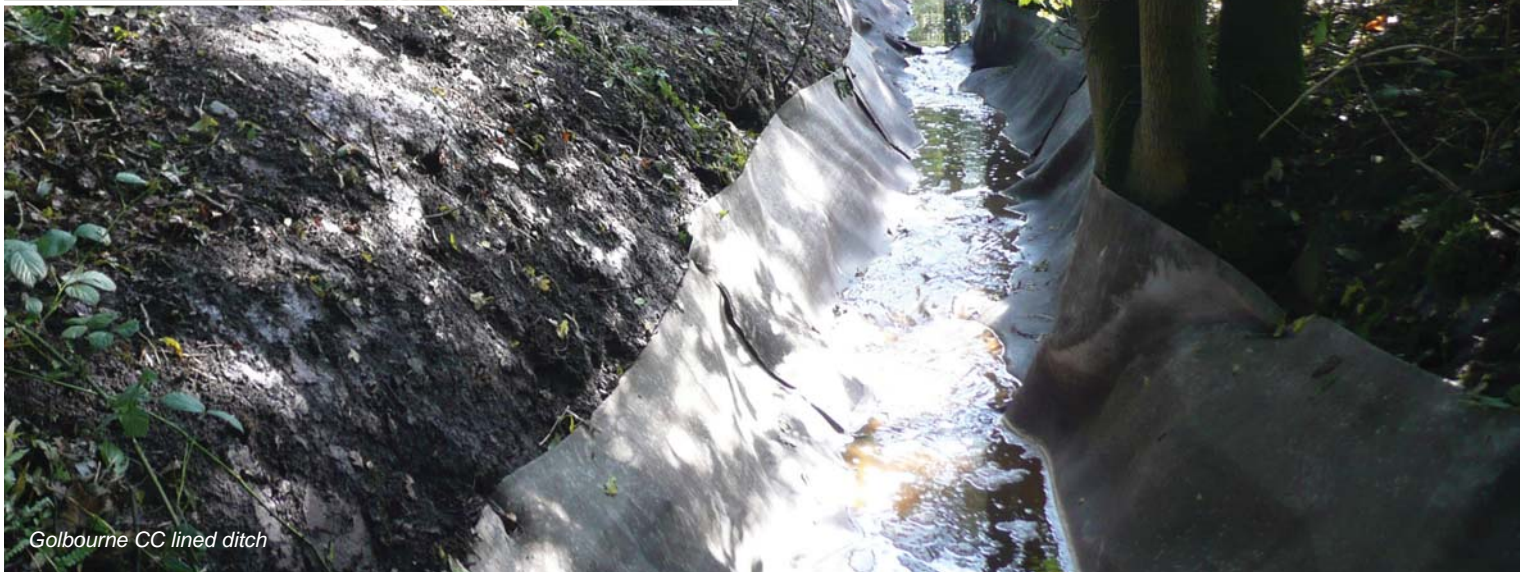
Golbourne CC lined ditch

Network Rail contracted Murphy Group to clear and line an open drainage ditch that had been clogged by growth and was at risk of destabilising the railway embankment. Concrete Cloth (CC) was specified to line the cleared ditch to prevent further growth and to stabilise the bank. The access to the site was poor, across farmland and located within a copse on a steep bank that ran along a high speed rail line. The use of CC allowed Murphy group to line the 120m long ditch in just 1.5 days.
